# Manhole Inspection Summary

Manhole # S45II\_007MH

Insp Date: **4/29/08 12:52 PM**

**Location** Address: **Washington St**

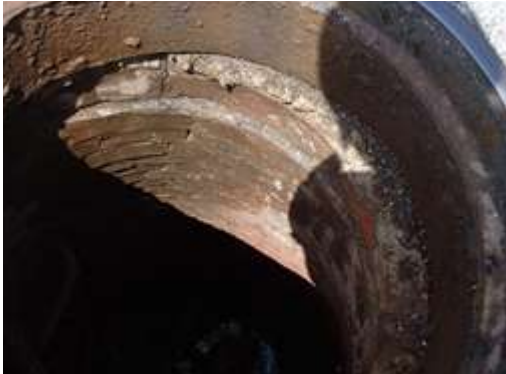
Defect 2

**Chimney / Frame Adjustment** ☒ Exists Material: **Brick** ☐ Parged Height: **12** (in.)  
Condition: ☐ Sound ☐ Cracked ☐ Root Intrusion ☒ **Loose Brick** ☐ Deteriorated  
Infiltration: ☐ None ☒ **Joint** ☐ Cracks ☒ **Mortar** ☐ Roots ☐ Wall

Loose Bricks

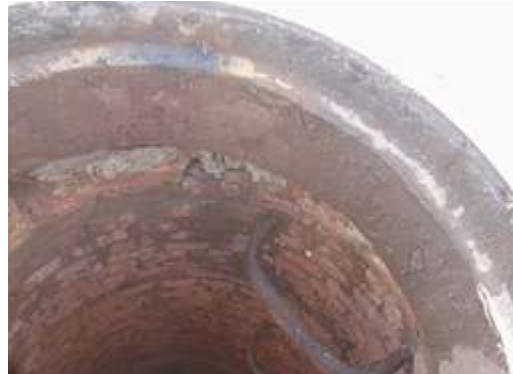
Defect 1

Deterioration

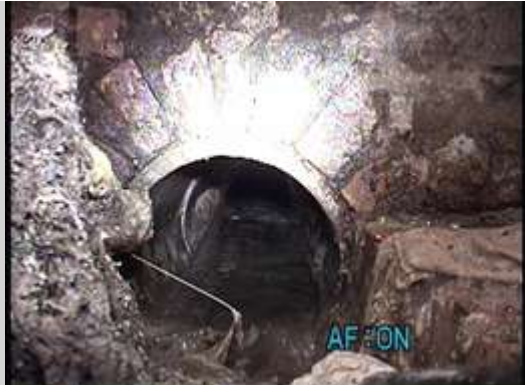
12 O'Clock Outflow

10 in. Circular Gravity Sewer  
Pipe Out @ 12 O'Clock

Pipe Height: **8.4** (in.) Rod and Bar (Angled)  
Pipe Material: **Clay** ☐ Pipe Lined  
Invert Depth: **10.30** (ft.) Flow Characteristics: **Fast**  
Deposits: ☐ None ☐ Mud ☐ Sludge ☒ **Debris** ☐ Grease  
Silt Depth: **2** (in.) Deposits Extent: **Light**  
Infiltration: **None** Pipe Seal Cond: **Sound**

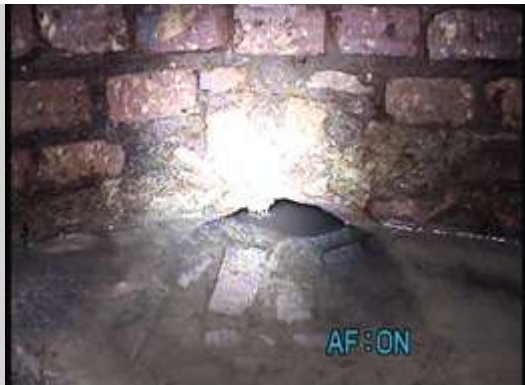
9 O'Clock Inflow

10 in. Circular Gravity Sewer  
Pipe In @ 9 O'Clock

Pipe Height: **8.4** (in.) Rod and Bar (Angled)  
Pipe Material: **Clay** ☐ Pipe Lined  
Invert Depth: **10.10** (ft.) Flow Characteristics: **Fast**  
Deposits: ☒ **None** ☐ Mud ☐ Sludge ☐ Debris ☐ Grease  
Silt Depth: (in.) Deposits Extent:  
Infiltration: **None** Pipe Seal Cond: **Sound**
